Rebuilding a Fin/Fan Structure

with Five Star® DP Epoxy Grout

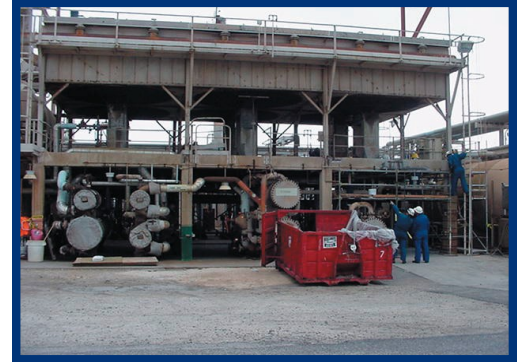
Fin/Fan structure in Hawaii

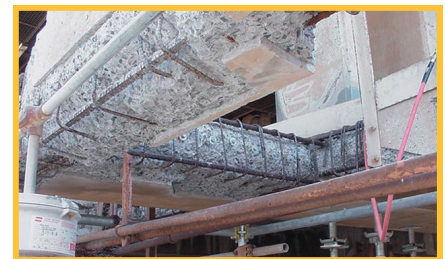
Surface preparation

Removing damaged concrete

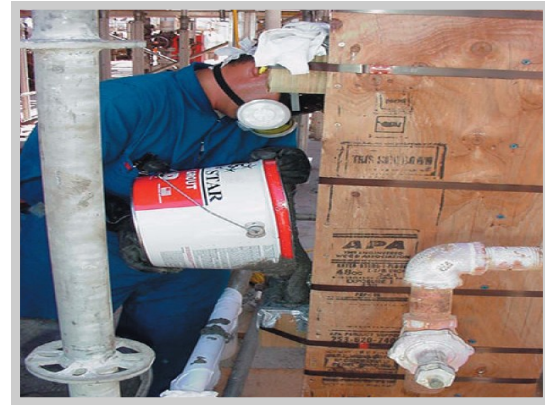
Pouring columns with Five Star DP Epoxy Grout

The **Five Star DP Epoxy Grout** was mixed in a mortar mixer and placed in varying thicknesses – from 2 to 8 inches in depth in a single pour. The unique low-exotherm characteristics of **Five Star DP Epoxy Grout** allowed thick pours without the potential problem of stress cracking.

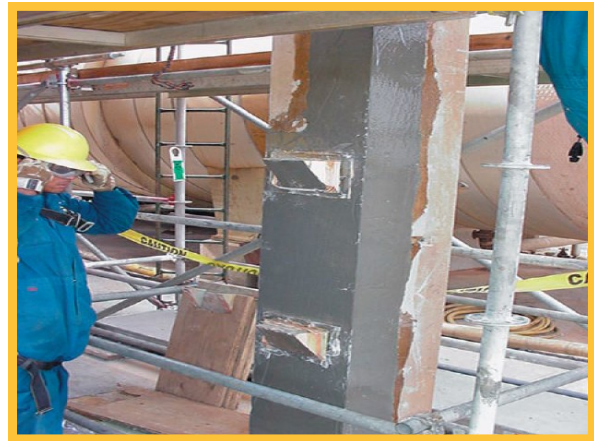
Concrete pour forms before removal

A detailed repair procedure was developed by Five Star. In conjunction with the customer, a test protocol was initiated to determine whether or not **Five Star DP Epoxy Grout** could be placed during vibration, develop excellent bond strength, and result in a permanent repair. The test was run on selected areas within the fin/fan structure, representing the “worst-case” locations, based upon vibration amplitudes measured previously by the customer. The areas to be repaired were chipped to sound concrete, and clear Plexiglas forms were installed for visual observation of the product both during and after placement.

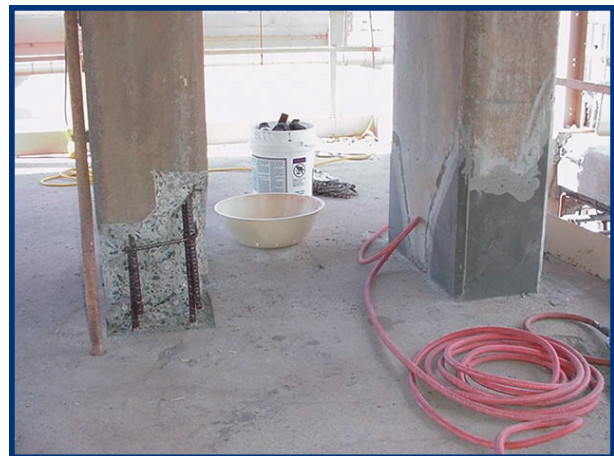
Columns before and after repairs

Five Star Products, Inc. provided technical field personnel for the repairs at no cost to the customer. The fin/fan structure retains its structural integrity and remains fully operational to this day. This West Coast Refinery was extremely pleased with Five Star’s performance and superior technical on-hand support, as well as the quality of its **DP Epoxy Grout**. Five Star provided quality products, technical know-how, and quick turnaround to the owner, making this a true Five Star solution.
