SOLUTIONS | Case Study

Dock Pile Restoration Phase 1 Deer Park, TX

Dock Pile Restoration Phase 1

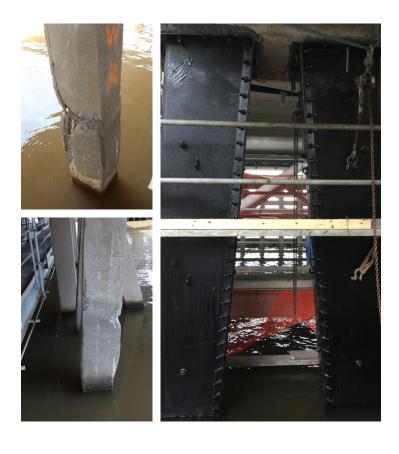
The Five Star Products marine division was presented with the challenge of designing a custom metal sleeve to fit the irregular shaped rectangular batter piles that tapered from a 24" x 24" section down to a 20" x 20" section closer to the water line. Another obstacle was presented in that one pile must be fully repaired before the other could be repaired because the piles and pile bent were not strong enough to simultaneously support the weight of both metal sleeves during installation.

To resolve the issue of the difficulty in manufacturing a tapered metal jacket, it was decided to use 20' long, 26" x 26" rectangular, two-piece jackets to be clamped at opposite corners around the piles maintaining a 1" annulus between metal jacket and concrete at the top section tapering to a 2" annulus at the bottom section. Five Star® Pile Jacket Epoxy Grout LPL was chosen to fill the annular space between the jackets and concrete pile due to its mechanical properties, pumpable consistency, long working time, and ability to be placed underwater.

The basis of the repair system relied on the high compressive, flexural and tensile strengths and superior bond of the epoxy grout to the concrete and metal surfaces to transfer any lateral and downward forces from the deck above through the pile to the rigid metal jacket.

After delivery of material and staging of equipment, the entire project was completed in only 4 days (2 days per pile). The piles were restored to full capacity after the grout cured for just 24 hours.
