S L U T I O N S

Pier Pressure: The Rehabilitation of NYC's Passenger Ship Terminal Piers 88 & 90

In 2012, the New York City Economic Development Corporation awarded the contract for rehabilitation of Piers 88 and 90 to Reicon Group, LLC. Project engineers initiated an extensive two-part testing program to examine if alternative methods – namely, epoxy products – could remediate this pressing problem and satisfy both protective and structural repair requirements in a cost-effective manner.

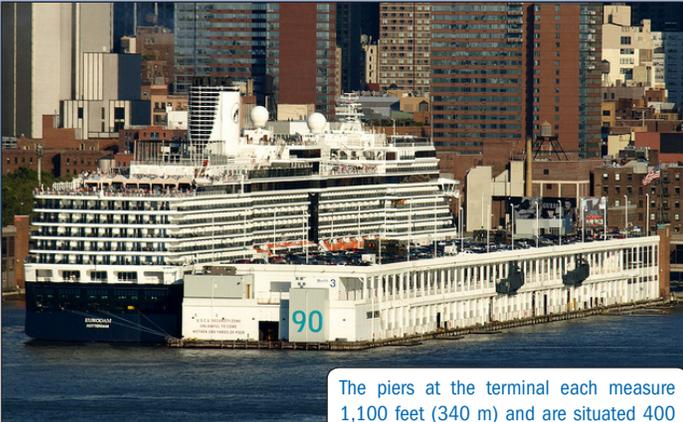
The piers at the terminal each measure 1,100 feet (340 m) and are situated 400 feet (120 m) apart; each pier is supported by roughly 1,500 untreated Douglas Fir timber piles, and concrete pedestals support a 10-inch (25 cm) reinforced concrete deck and the superstructure columns of the two-story steel-framed terminal building with roof parking deck.

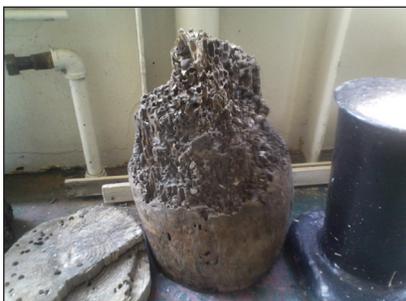
Pile degradation due to marine borer activity has been escalating at an alarming rate over the last 15 years. Some pile diameters now exhibit an hour-glass shape above the mud line, indicative of extensive damage, and in some extreme cases, piles are left dangling from the pile cap they were originally intended to support. A second area of concern is rot decay observed

in tidal areas just below the deck, with a large area of Pier 88 at one time deemed structurally unsound and incapable of supporting any live load until repairs could be made, greatly restricting the terminal's operation.

Engineers determined that a pumped epoxy-fiberglass jacket option would best meet their requirements as they would provide a hard-shell barrier protecting the wood against intrusion of marine organisms with an indefinite lifespan and almost maintenance-free protection. **Five Star's PileForm™ F fiberglass reinforced plastic (FRP) pile rehabilitation jackets were specified due to their ability to perform in hostile marine environments, with benefits that included easy installation and ease of pumping of the Five Star® Pile Jacket Epoxy Grout LPL.**

Phase One of the project began in June 2012, and comprised repair and re-encapsulation of 190 single piles. Five Star Products quickly formed a team to tackle the intricacies of the job. Although no special formulation was required for the Pile Jacket Epoxy Grout LPL, the grout did have to be pumped over distances in excess of 150 linear feet – and for one hard-to-reach area, 200 feet of hose were needed.
