PROJECT:

Pier Pressure: The Rehabilitation of NYC's Passenger Ship Terminal Piers 88 & 90

OWNER: Turner Construction Company

YEAR: 2013-present

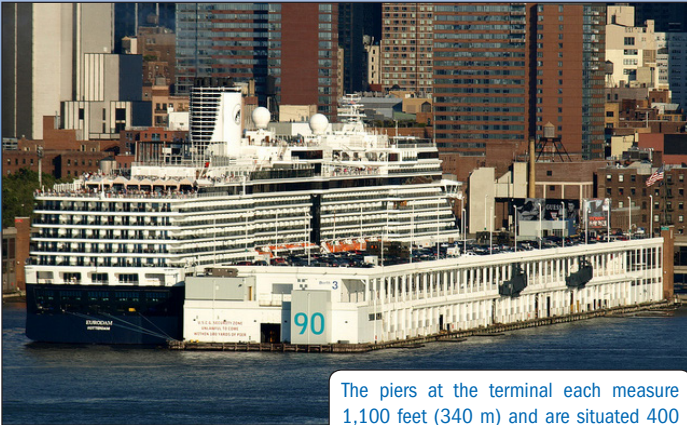
The piers at the terminal each measure 1,100 feet (340 m) and are situated 400 feet (120 m) apart; each pier is supported by roughly 1,500 untreated Douglas Fir timber piles, and concrete pedestals support a 10-inch (25 cm) reinforced concrete deck and the superstructure columns of the two-story steel-framed terminal building with roof parking deck.

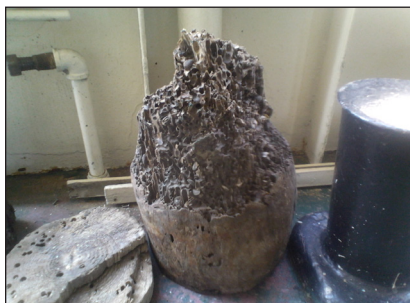
Pile degradation due to marine borer activity has been escalating at an alarming rate over the last 15 years. Some pile diameters now exhibit an hour-glass shape above the mud line, indicative of extensive damage, and in some extreme cases, piles are left dangling from the pile cap they were originally intended to support. A second area of concern is rot decay observed

Initial repairs to combat borer activity included installation of plastic barrier wraps, but this effort was met with limited success. The seals proved ineffective in reducing oxygen content sufficient to suffocate the borer organisms.

Engineers determined that a pumped epoxy-fiberglass jacket option would best meet their requirements as they would provide a hard-shell barrier protecting the wood against intrusion of marine organisms with an indefinite lifespan and almost maintenance-free protection. **Five Star's PileForm™ F fiberglass reinforced plastic (FRP) pile rehabilitation jackets were specified due to their ability to perform in hostile marine environments, with benefits that included easy installation and ease of pumping of the Five Star® Pile Jacket Epoxy Grout LPL.**
