SOLUTIONS | Case Study

City of Greater Geelong Manhole Lid Repairs

Geelong Victoria, Australia

Geelong Manhole Lid Repairs

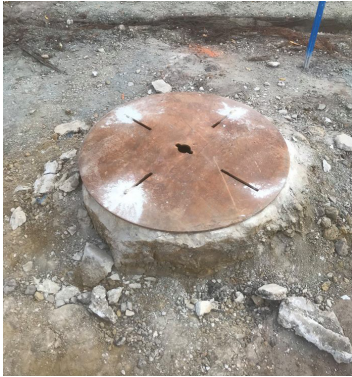
Manhole Excavation

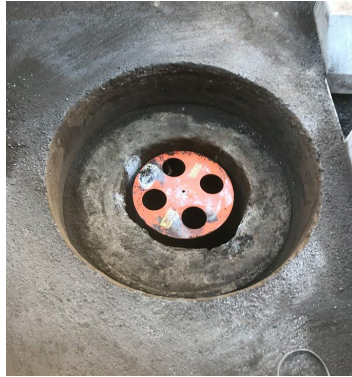
Manhole Preparation

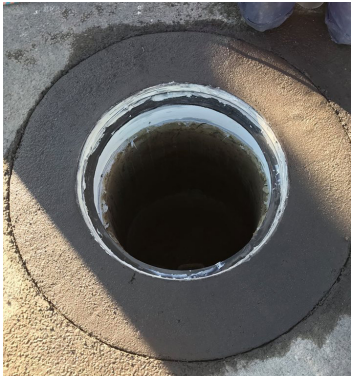
Five Star® Highway Patch placed to reinstate the substrate around the manhole.

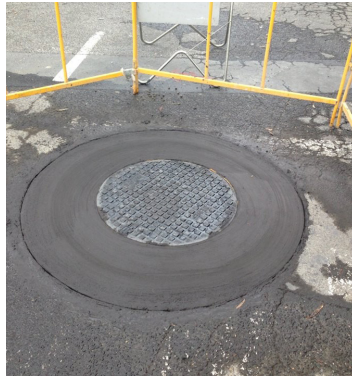
Completed manhole with Five Star® Highway Patch.
