Vertical Cracks in Epoxy Grout

Technical Bulletin 208

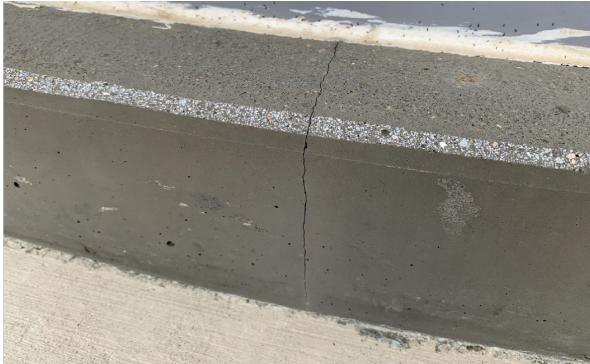
VERTICAL CRACK IN EPOXY GROUT

Epoxy grout vertical cracks and the effect they have on precision epoxy grout placements can be a concern if not properly addressed. These cracks usually occur after the grout has cured and gone through one or more temperature cycles. The cracks are typically visible in the shoulders and may or may not extend all the way through the grout.

These vertical cracks are a result of the grout “stress relieving” itself because of the different expansion and contraction rates of the various materials (steel, concrete, and epoxy) that are now bonded together as one foundation system. The crack can be viewed as the system forming its own expansion joint to relieve the internal stresses.

Vertical cracks in epoxy grout are typically small and are not the result of cracks in the foundation. Even if they extend past the

grout shoulder under the baseplate, the total surface area of all the cracks is so minute compared to the surface area of grout in contact with the baseplate that they have no effect on the compressive capability or the stability of the grout. The primary reason to address these vertical cracks is to prevent water and contaminant infiltration which can cause damage to the grout and the concrete foundation particularly if the grout and foundation are exposed to freeze/thaw cycles or chemicals.

The primary repair for a vertical crack in epoxy grout is to seal it. Cracks which are dynamic and susceptible to continued thermal expansion and contraction should be sealed with an elastomeric joint sealant. If it can be determined that the crack is not acting as a “stress relief control joint” and the stresses are relieved, a low viscosity epoxy material may be used to repair it. However, if the grout is sealed with a low viscosity epoxy material and the internal stresses still need to be relieved, it is likely to crack again. Some equipment owners seal the cracks initially with a low viscosity epoxy repair material rather than repair the crack with a flexible material (i.e., elastomeric joint sealant) because the repair is less obvious and does not always reoccur if the stresses are relieved.

1. Using a grinder with a diamond blade create a joint or groove directly over the existing crack on the horizontal and vertical surfaces of the shoulder. This joint should be roughly $\frac{3}{8}$ inches (9.5 mm) wide by $\frac{1}{4}$ inch (6 mm) deep.
2. Clean the joint using oil free compressed air to remove any dust and keep the area dry.
3. Place tape along the edges of the newly created joint.
4. Apply elastomeric joint sealant or low viscosity epoxy material to fill the joint. Make sure the prepared crack is full.
5. Remove tape before the sealant cures.

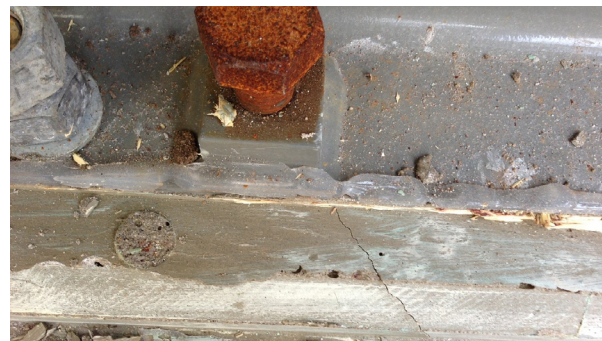
- Embedded steel leveling mechanisms (such as shims) that are placed too close to the perimeter of the grout and not placed parallel to the edge of the baseplate
- Shims and Jack bolt bearing pads that are square in shape without radiused corners
- Interior corners where the forms cause a sharp 90-degree point load
- Anchor bolts that are prematurely torqued
- Excessively large grout shoulder
- Premature removal of forms and/or forms bonding to the grout requiring excessive force to remove

VERTICAL CRACKING OFF A JACK BOLT

- Restrict the width of the shoulders to 3 inches (75 mm) or less.
- Adhere to the epoxy grout manufacturer’s technical data sheet for maximum volume and depth limitations.
- Provide expansion joints on 4-foot to 6-foot (1.2 m – 1.8 m) centers across the short dimension of equipment placement.
- Do not embed or encapsulate the soleplate or baseplate in the grout.
- Generously round any corners on shims and jack bolt landing pads embedded in the grout and keep these items 2 inches (50 mm) away from the edge of the grout and parallel to the baseplate.
- To protect anchor bolts and jack screws from epoxy grout bonding to them, coat them with a bond breaker material or wrap them in duct tape or a protective sleeve.
- Follow appropriate anchor bolt tightening procedures.

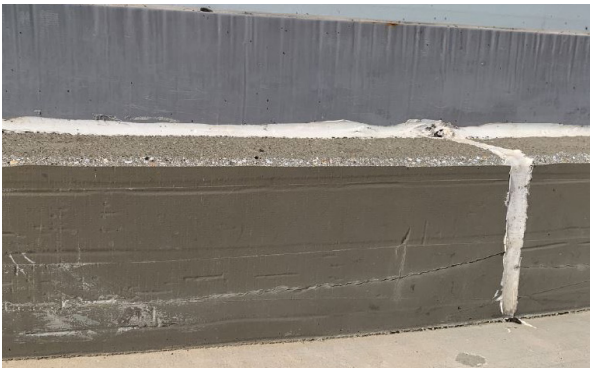
VERTICAL CRACK REPAIR IN EPOXY GROUT USING ELASTOMERIC JOINT SEALER
